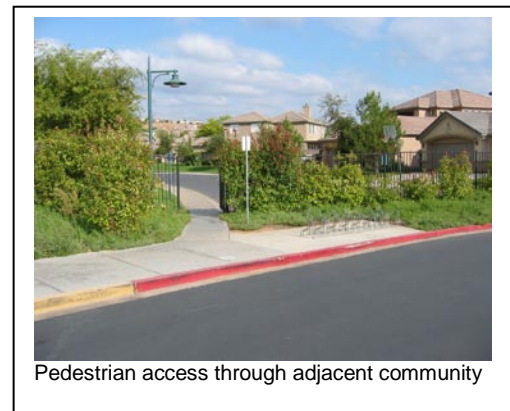
Pedestrian access through adjacent community

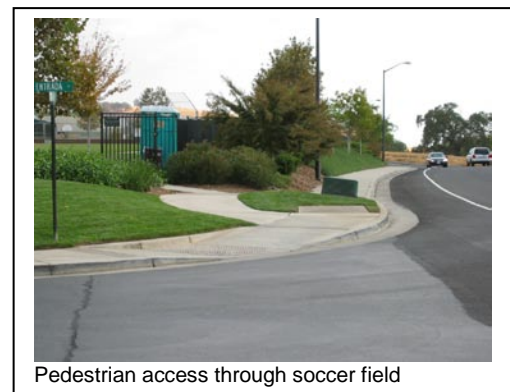
Pedestrian access through soccer field

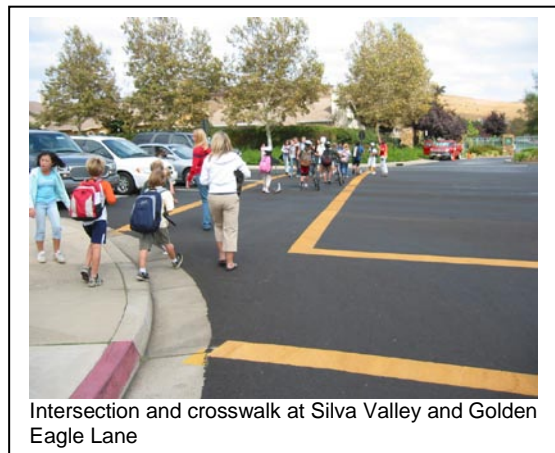
In September 2007, EDCTC and DOT staff conducted an audit at Silva Valley Elementary School in the afternoon. During this audit, it appeared many children were walking with parents, or alone, and many more were being picked up by parents in cars. A number of children may have been walking from the school site to parents' vehicles parked along Silva Valley Parkway. There are normally two crossing guards working at the intersection of Silva Valley Parkway and Golden Eagle Lane. On the occasion of our audit, only one crossing guard was available. The audit team estimated that over 200 persons crossed at the target intersection during the afternoon audit.

Intersection and crosswalk at Silva Valley and Golden Eagle Lane

1. Add an additional bike rack.
2. Stripe crosswalks with high visibility, international standard or ladder-style crosswalks.

1. Appoint three crossing guards to the Silva Valley and Golden Eagle Drive intersection.
2. Implement Walking School Bus drop-offs at a safe nearby location to encourage walking and to divert traffic from the school site.
3. Start a bicycle education program and facilitate a bike rodeo to encourage safe bicycling.
4. Implement a School Rideshare Program through "Smart Routes to School."

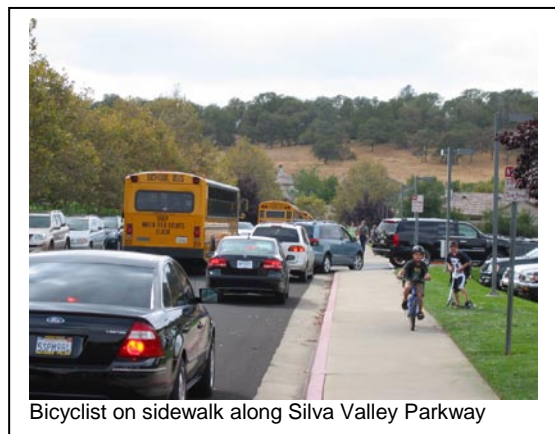
Bicyclist on sidewalk along Silva Valley Parkway

When the audit was conducted, during the afternoon in September, the existing bike rack was overloaded with bicycles and scooters. Many children were seen riding their bikes from the school site on the five-foot wide separated sidewalk along Silva Valley Parkway. However, children were not observed riding their bikes in the four-foot paved shoulder along Silva Valley Parkway due to the permitted on-street parking used by parents waiting to pick up their children. The same shoulder is blocked by cars parked all day near Oak Ridge High School.

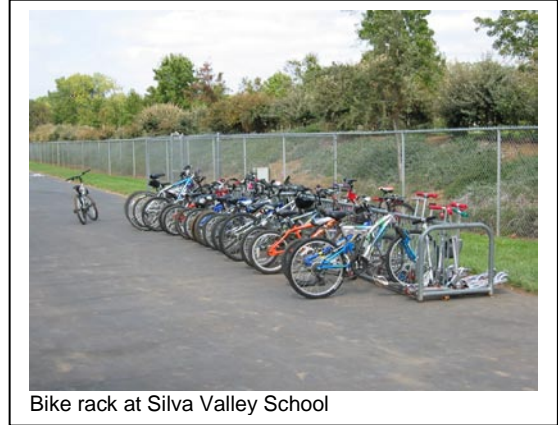
Bike rack at Silva Valley School
