Pinewood School: K-4 with 415 Students

6181 Pine Street, Pollock Pines

Audit Conducted: 2/15/2008

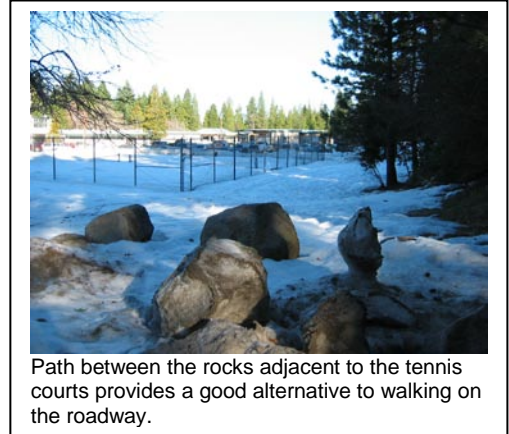
The school was audited during the morning drop-off period in February of 2008. One parent was observed walking a child to school. This parent indicated that she usually walks on a dirt path adjacent to the tennis courts to stay away from the cars lined up at the entrance of the school. However, this day that area was covered in snow. This type of informal route makes for an excellent passage for pedestrians. Many children are bused to school and several are driven to school by parents. Approximately four to five cars were lined up at the parking lot entrance during this peak time. The roads adjacent to the school are narrow and have no sidewalks or shoulders. Typically, narrow roads such as these help keep car speeds low, but it does not leave room for pedestrians to feel comfortable. Additionally, Laurel Street is located on a hill, which tends to encourage higher car speeds.

Path between the rocks adjacent to the tennis courts provides a good alternative to walking on the roadway.

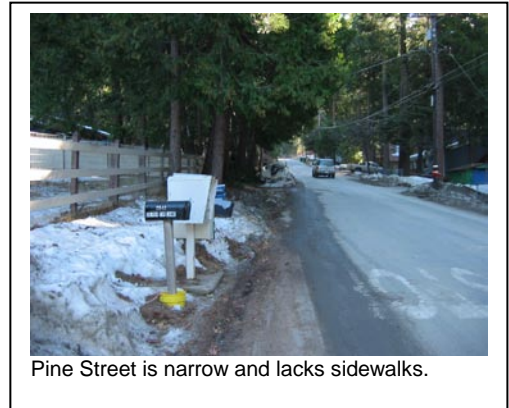
- ✓ Good location within a neighborhood.
- ✗ School does not have a bike rack.
- ✗ No shoulders or sidewalks at entrance or on nearby roads.

Pine Street is narrow and lacks sidewalks.

1. Restripe the crosswalk at Laurel and Pine Streets.
2. Add sidewalks on Pine Street.
3. Stripe crosswalks on all four legs of the intersection of Laurel and Pine Streets.
4. School zone signage.
