## **Gold Oak School: K-5 with 386 Students**

## **Gold Oak Arts Charter School: 4-8 with 102 Students**

3171 Pleasant Valley Road, Placerville

Audit Conducted: 2/13/2008

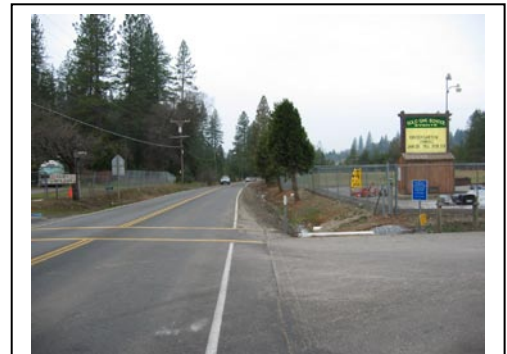
Crosswalk and narrow shoulders present in front of Gold Oak School.

1. Implement a school rideshare program through "Smart Routes to School."

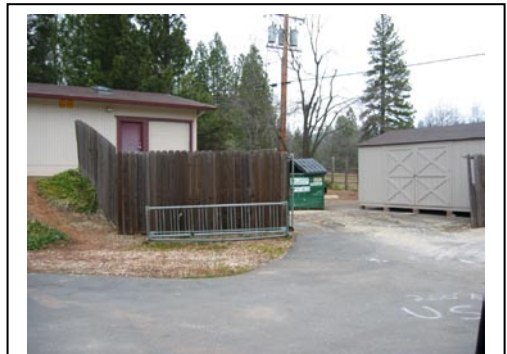
Bike rack at Gold Oak School
